# LAUNCHING LIBERTY

## CLIPPER ADDRESSES TEETHING ISSUES

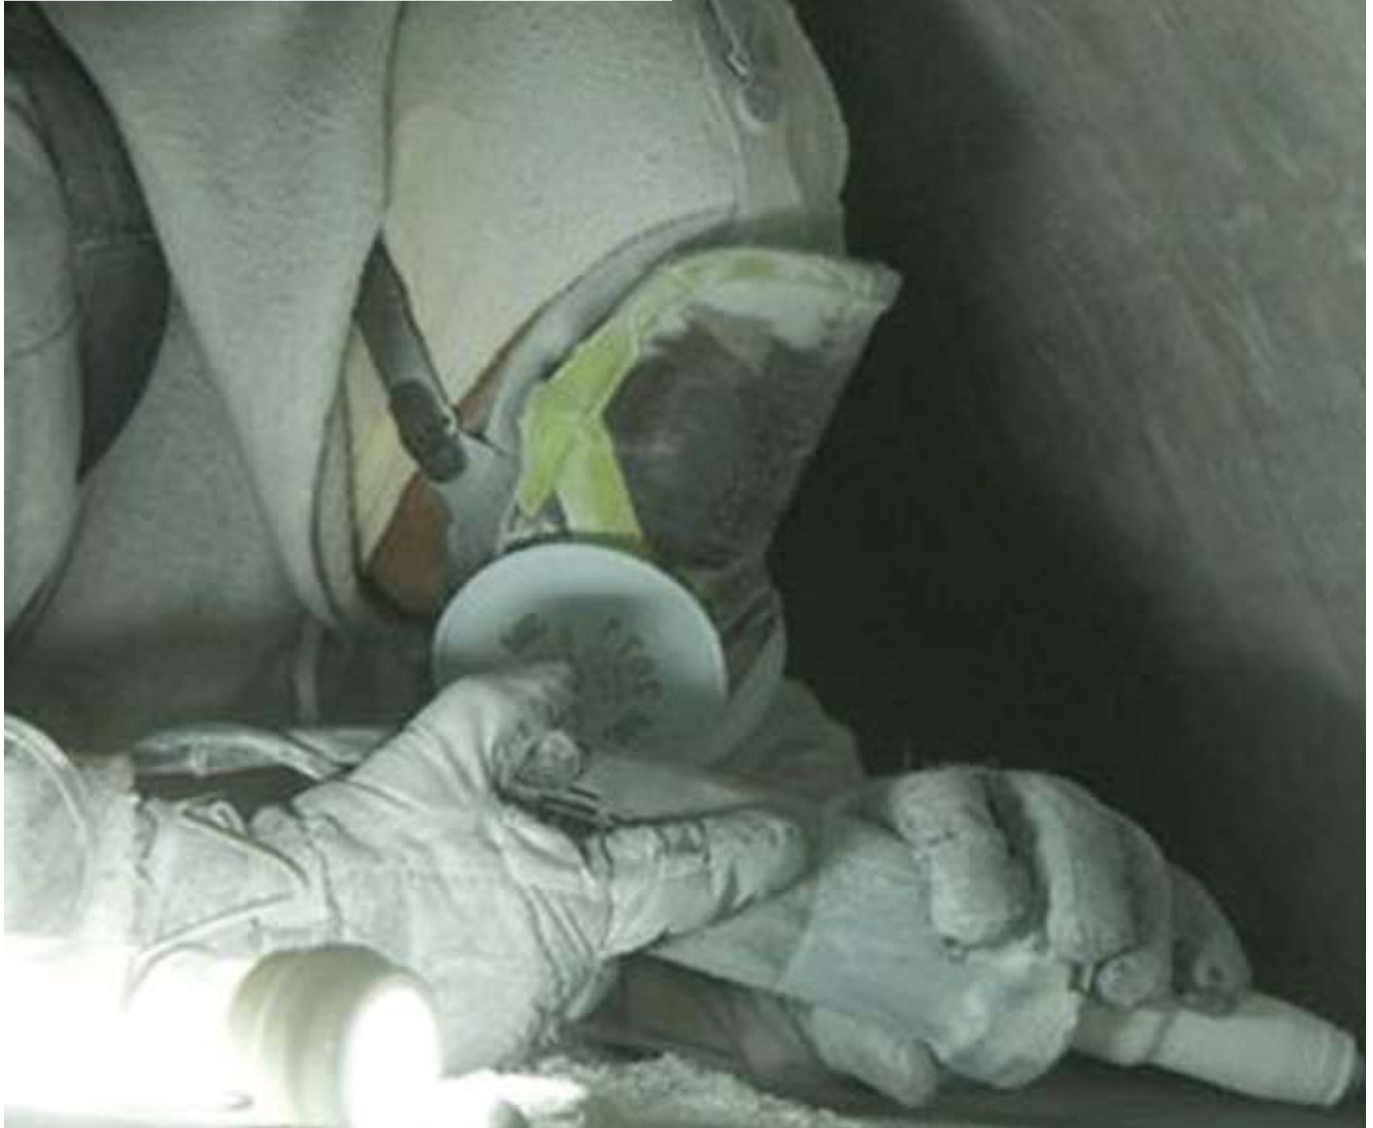
Grinding preparation for rotor blade reinforcement CLIPPER

One of the fleet service personnel also heard an unusual noise coming from one of the rotor blades at the same project site. Christenson explains: 'We stopped the machine to inspect the blades and found that an internal structural reinforcement panel in the root area of the blade had come loose. This panel, referred to as the aft shear web, is a longitudinal secondary spar that connects the high pressure and low-pressure skins to each other in the maximum chord area of the blade. However, the connection of the spar to the blade skins was found to lack the required strength to withstand the loading experienced during turbine operation.'

Out of 250 blades inspected, this problem was found to exist in approximately 20 blades, says Christenson. 'However, we decided to conduct a rotor blade reinforcement of the entire fleet by adding a shear clip that strengthens the connection of the spar to the blade skins. The fiberglass reinforcements provide additional structural integrity to the rotor blade and assure its 20-year design life. The root cause and corrective action was identified through the same DMAIC process and used on the drivetrain issue. Similar blade reinforcements have now been integrated into the design of factory-built blades currently in serial production. The blade reinforcement concept was initially validated using coupon tests and a blade static test, and is now being confirmed with blade fatigue testing.'

Maurer says Clipper has segmented the blade remediation process into a series of steps – surface preparation; lamination, post cure and clean-up. 'Surface grinding the remediation area on the blade is required as a preparation step for applying lamination. Due to winter conditions, heating elements as well as industrial electric blankets were placed around the blade to produce the required temperature for curing. We also rig up a lighting system and generators to power the lights and hot air units to warm the inside of the blade. Further, we utilize a control system to assure blades are heated or cooled to a

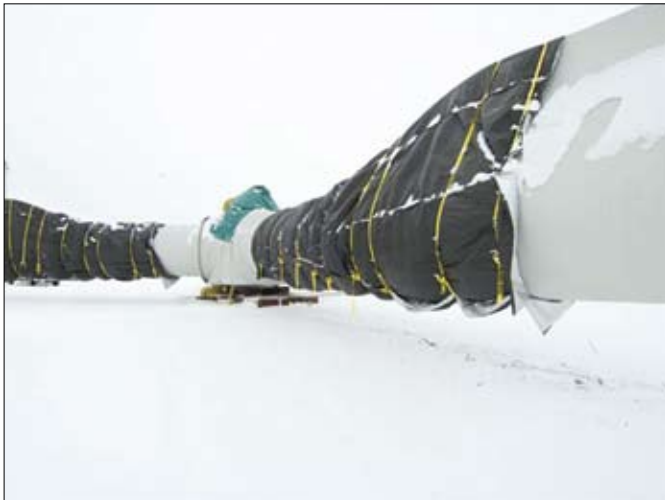
**Rotor with thermal insulation wrap to facilitate curing of laminate during blade reinforcement**

certain constant temperature to assure the fiberglass cures properly. Between each phase, a quality inspection is conducted by one of our independent Quality Control specialists to verify the blade meets our requirements before moving on to the next step. During our work we had to deal with winter temperatures, gale force winds, snow, sleet, rain, a lot of mud, and other challenges.' In fact, Clipper decided to start at the site with the coldest climate: 'Our reasoning was that if we could figure out how to cure in cold temperatures, we could do it anywhere. Although it was extremely difficult, we pulled it off within a month and have since been exporting the process to sites across the country.'
